# Humber, Ford and Stoke Prior Bridleways

Annual Report - 2021

Iain Cholerton  
1<sup>st</sup> May 2021

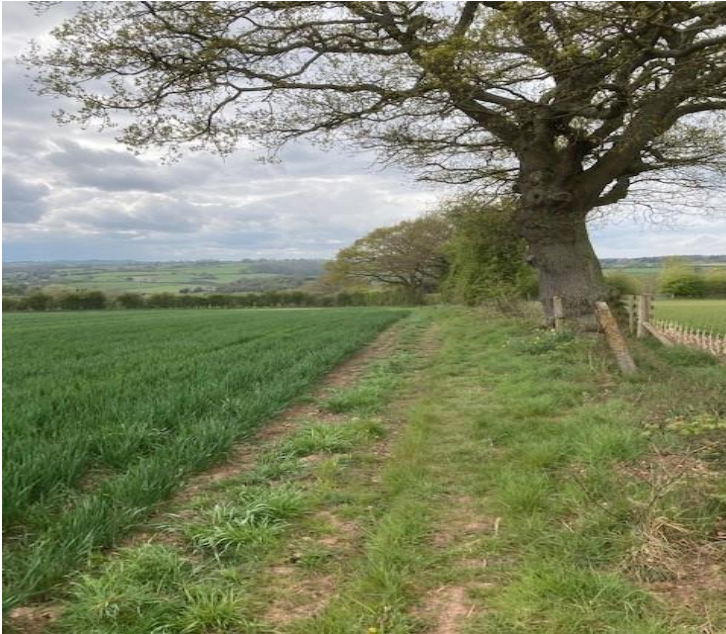
Photo 1. FD 3 (April 2021)

After leaving the Golf Course the route runs up alongside a field to gate SP28.4. The landowner is now maintaining an excellent strip for riders along this headland (Photo 1).

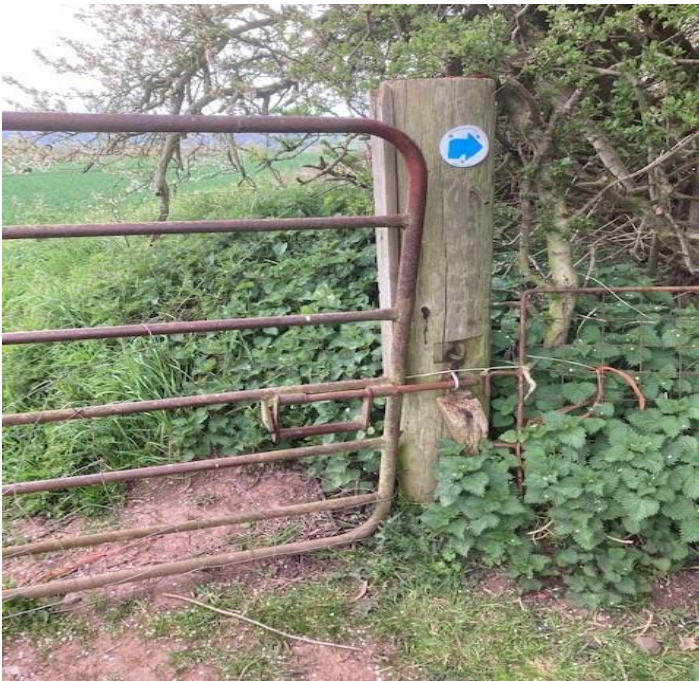
Photo 2. SP 28.4 (April 2021)

Gate SP 28.4 remains in need of replacement (Photo 2); the gate was worked on in 2019 so the latch now closes but it is still too low for a mounted rider to be able to open and close and requires two hands to move the gate. **No change since 2019.**

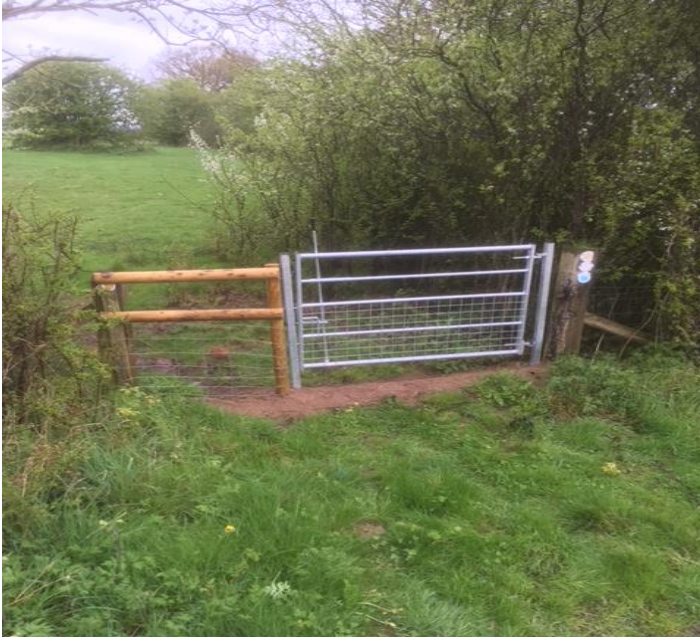
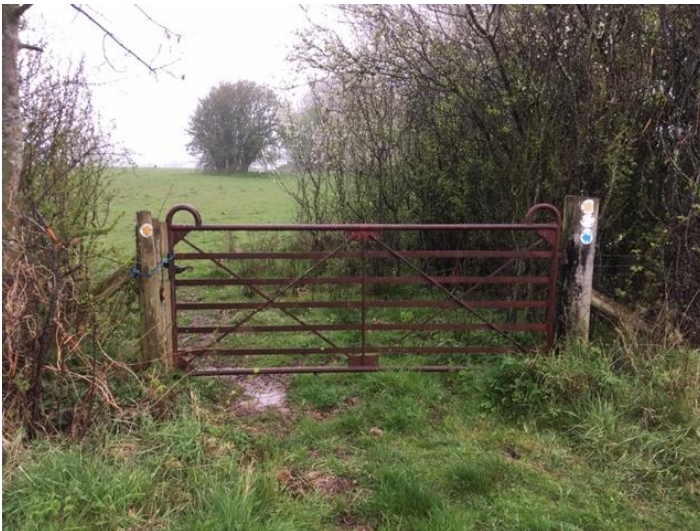
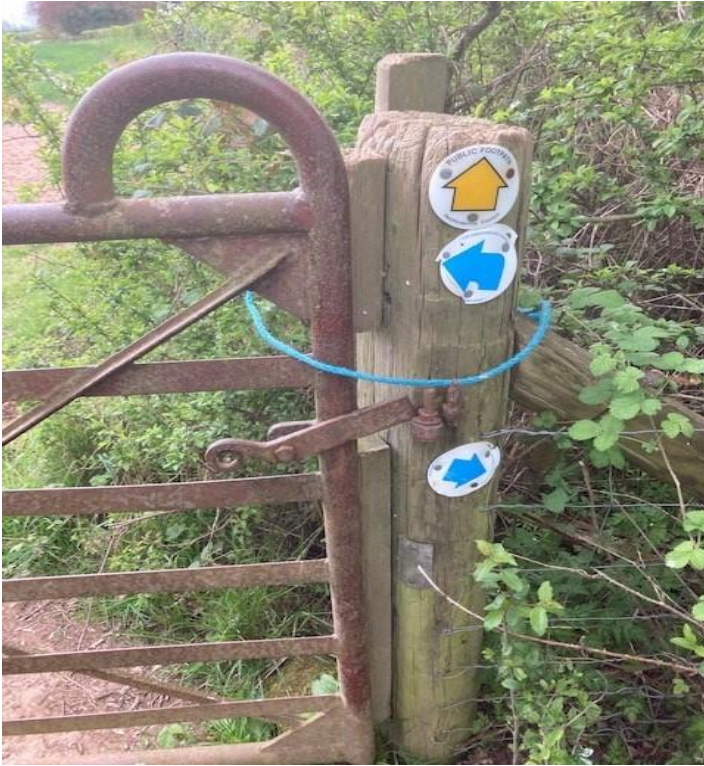
Gate No SP 28.3 was replaced in 2018 with a rider-friendly gate and the undergrowth cut back (Photo 3). But the landowner insisted the previous old metal gate be restored (Photo 4). This gate has an old metal latch that cannot be opened from the mounted position (Photo 5), so the latch is left off and a rope has been attached that can be raised from the mounted position to open the gate. **No Change since 2019.**

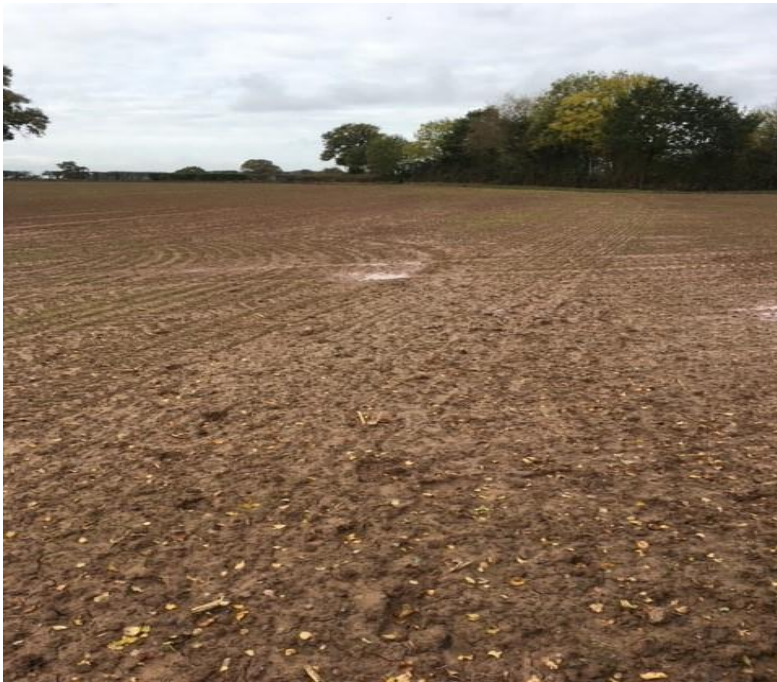
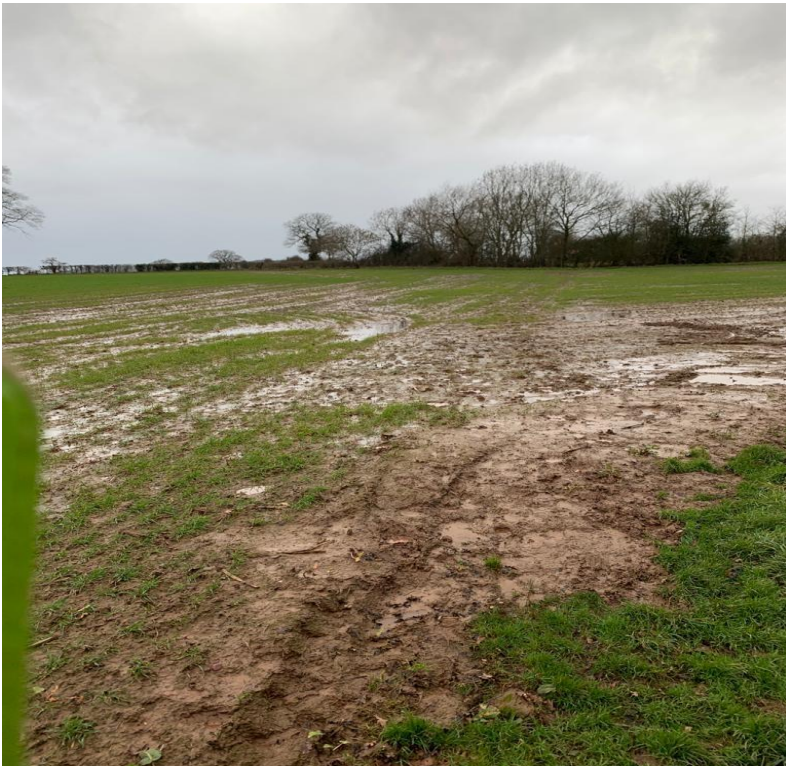
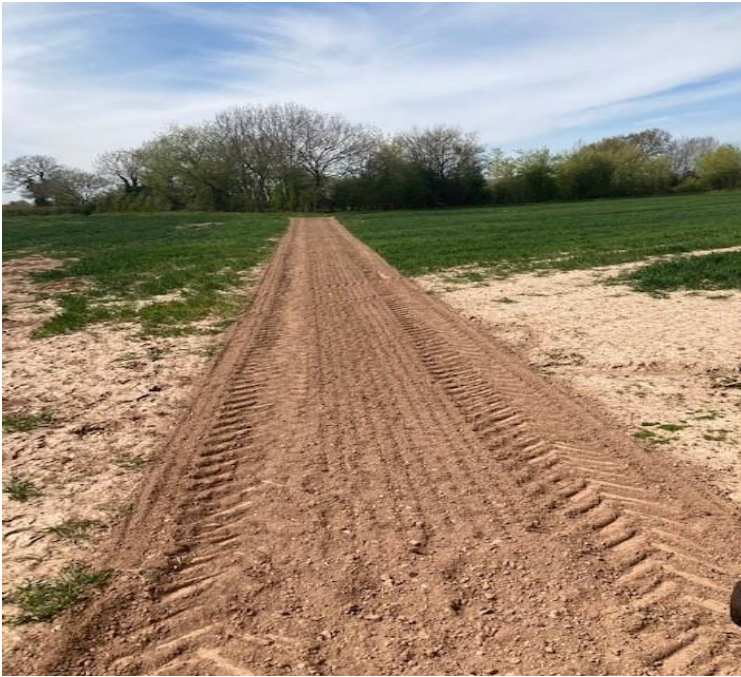
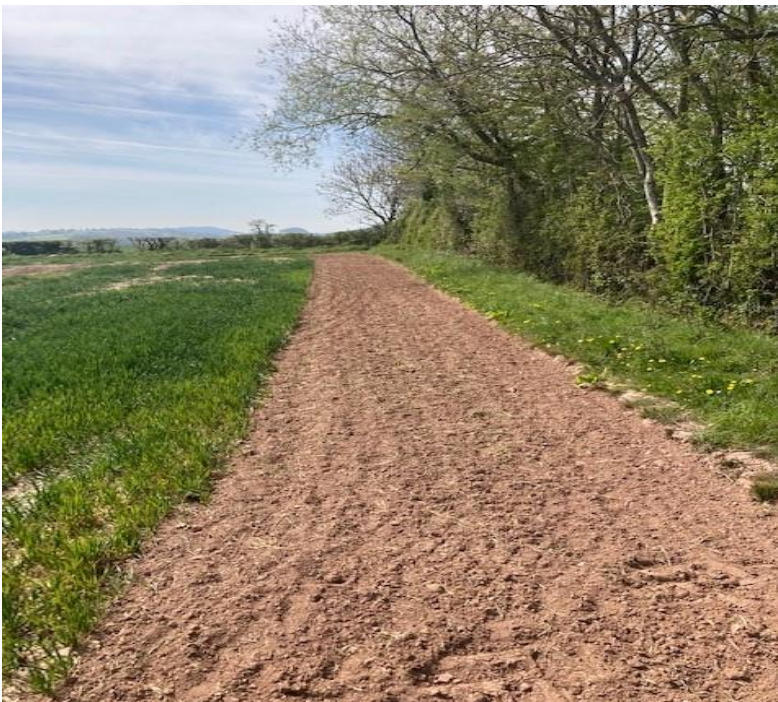
The route across from SP28.3 to Briery Mere (Photos 6, 7, 8 and 9) has been impassable for many months this year – as in previous years. It was ploughed in September and planted in October, directly over the PROW with no restoration work conducted throughout the winter despite the engagement of the Parish Clerk and discussions with the landowner about re-routing the PROW around the edge of the field (which he declined to consider). The wet winter exacerbated the situation and as a result most riders avoided the route which was dangerous for horses and risked injury to tendons if used.

The “restoration” work by the landowner was finally completed at the end of April, nearly 7 months after it was ploughed and drilled.

From the edge of the field, the restored route runs parallel to the hedgerow to SP28.3. It is to be hoped that in future this part will not be ploughed again and over time will become firm and passable throughout the year.

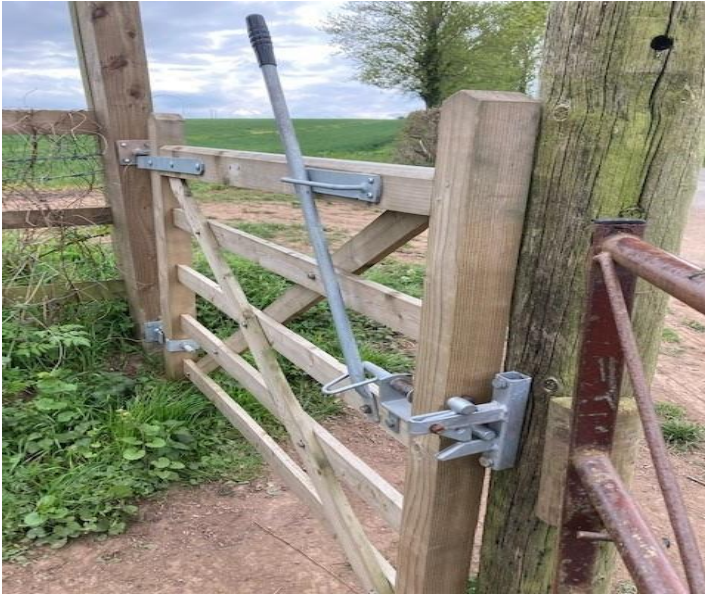
Photo 10. SP 28.2 (April 2021)

From Wickton Lane, SP28 then heads through a new gate SP 28.2 (Photo 10). This gate was replaced in 2019. Regrettably, the gate furniture was incorrectly fitted, and the handle does not open the latch even when fully pulled to the open position. This requires riders to dismount and open the latch by hand. The route alongside the crop through the field towards Witsets continues to be clear and well maintained.

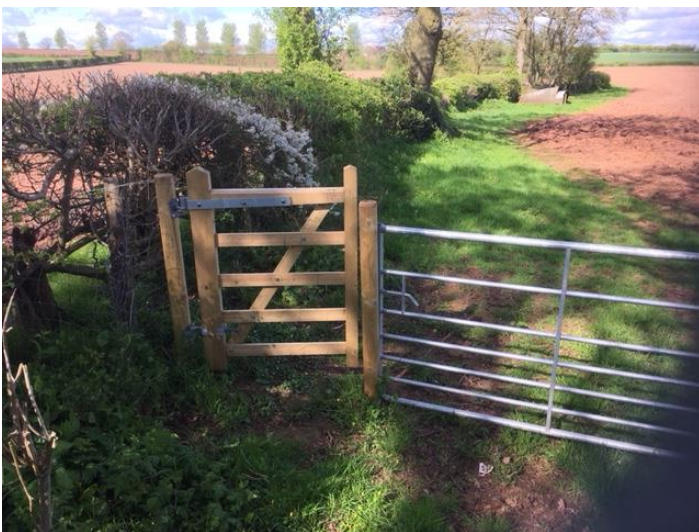
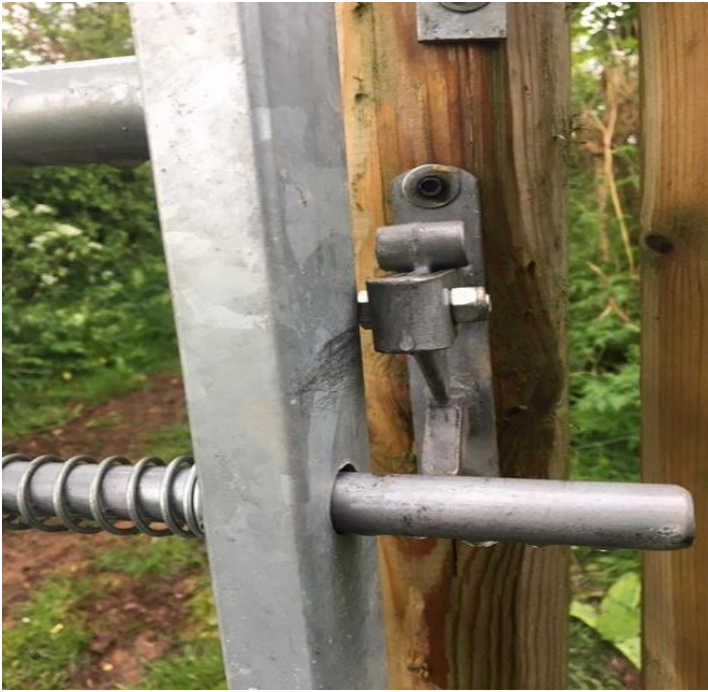
Gate SP28.1 (Photo 11) at the entrance to the narrow lane leading to Bowley Lane was replaced in 2017. Regrettably, the replacement wooden gate is too narrow for a horse to pass through safely and requires riders to dismount and open the larger metal gate. This metal gate cannot be closed as the bar does not fit into the catch. The gate also drags along the ground as it was mounted incorrectly when first installed (Photo 12), so riders have no alternative but to leave it open. **No Change since 2018.**

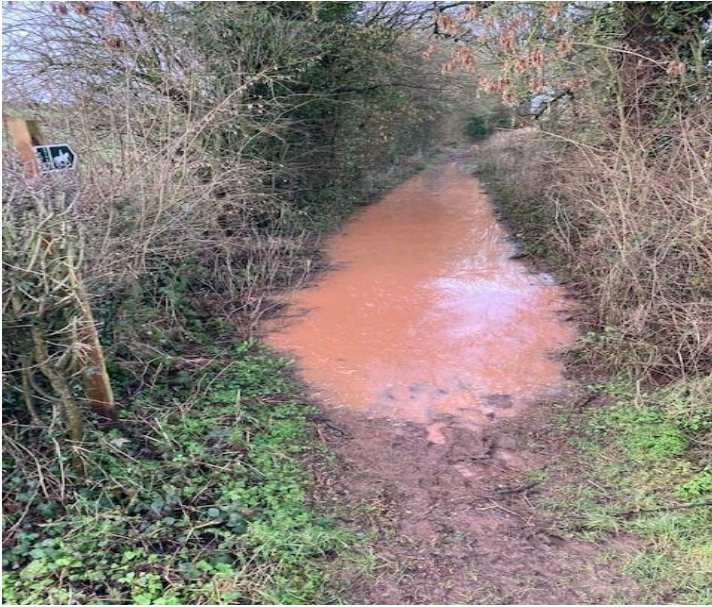
Photo 13. SP28 (February 2021)

The route then exits the narrow lane onto the road South of the Witsets. The area here is prone to flooding (Photo 13) with water running off the field to the South and was impassable for many months of the year.

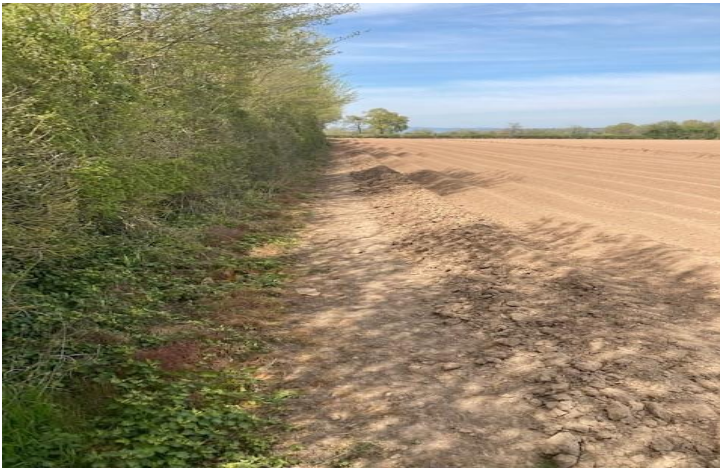
Photo 14. (April 2021)

The route starts from SP 28 at Briery Mere heading towards Norman’s Farm. Potatoes have been planted quite close to the edge of the field this year, but it is still passable although not of the required width (Photo 14).

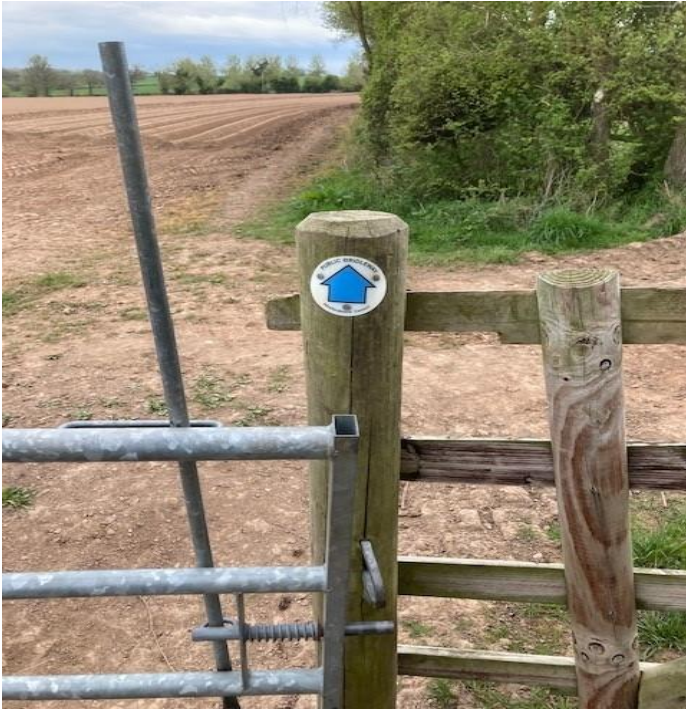
Photo 15. SP 12.2 (April 2021)

Gate SP 12.2 (Photo 15) after opening, cannot be closed when mounted as it has dropped slightly, and the latch will not fit except by lifting the gate with two hands.

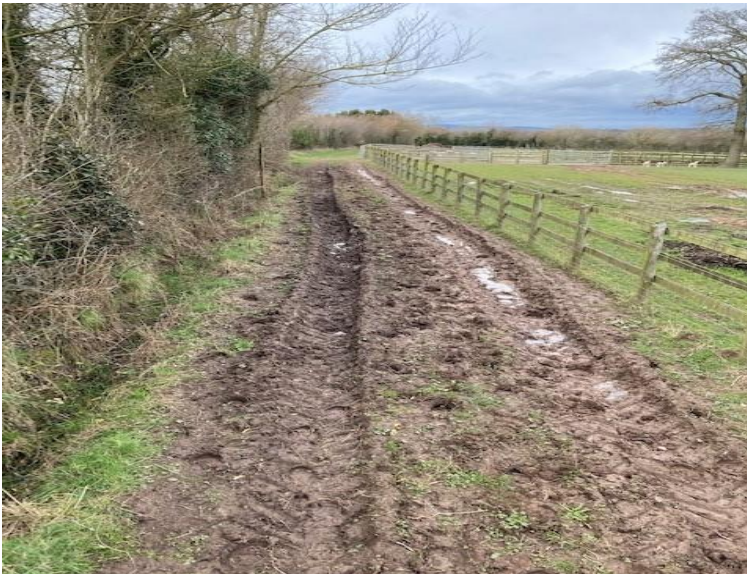
Photo 16. SP 12 2-3 (March 2021)

The route between SP 12.2 to SP 12.3 has been deeply rutted this year by farm traffic making it difficult to use (Photo 16).

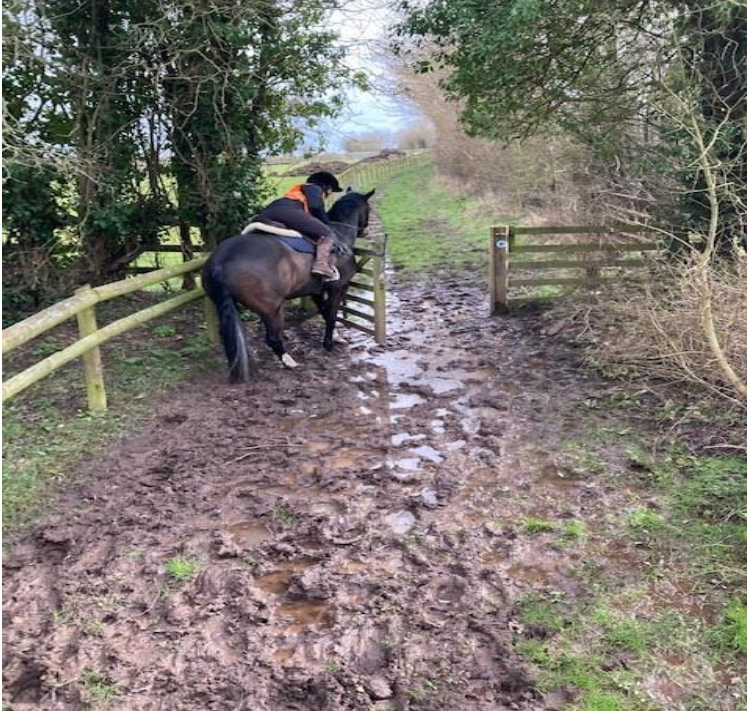
Photo 17. SP 12.3 (March 2021)

The PROW officially ends before gate SP 12.3. The gate is passable on horseback but in winter very deep in mud, making it difficult to use. The request for the PROW to extend down into the village with a diversion around Norman's Farm is still ongoing I believe.

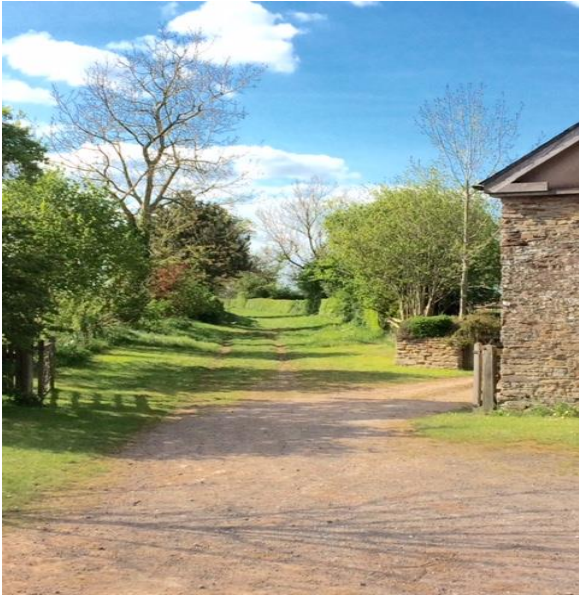
Photo 18. (2017)

Access from Witsets to Wickton Lane is clear (Photo 18), well maintained and regularly topped with hedges trimmed back (many thanks to the Lengthsman and Pete L-H). It has this year periodically seen some illegal quad bike traffic (NFI) using this route up from the village that has rutted the track during wet weather.

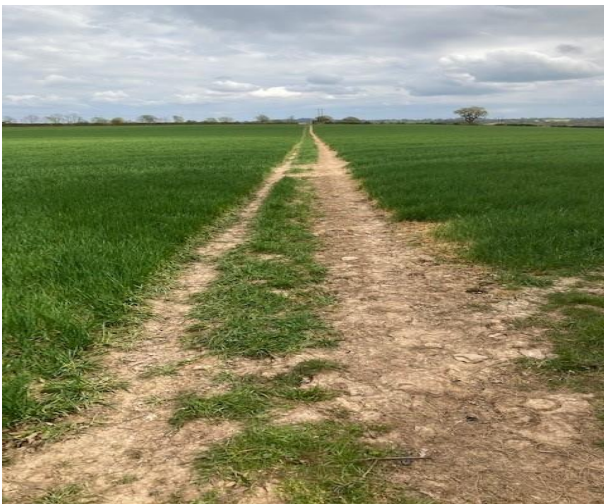
Photo 19. SP27 (April 2021)

Crops continue to be planted directly over the PROW from Wickton lane (Photo 19), but a path was again restored through the crop that made the route passable for most of the year. The rest of the route is passable including the gates SP27.1 and SP27.2.

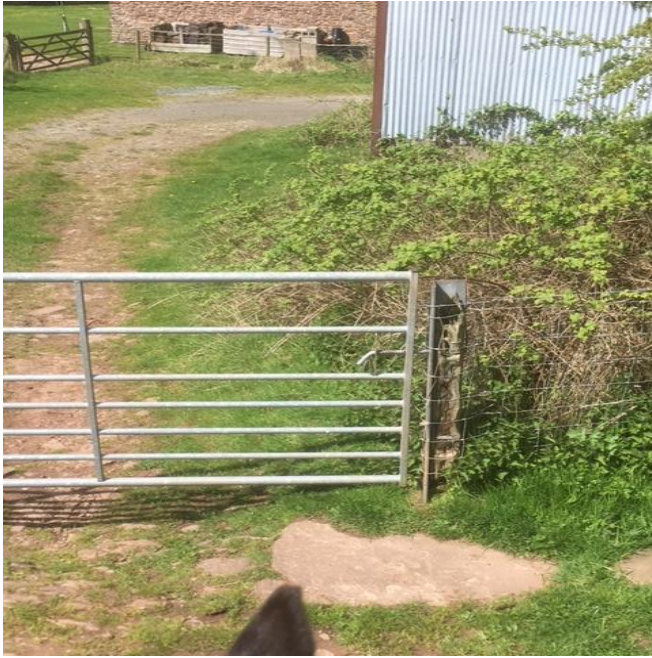
Photo 20. HU 4.1 (2018)

Entrance to the route is through gate HU 4.1 behind Humber Court that requires riders to dismount (Photo 20), open with two hands and lift to swing open. **No Change since 2018.**

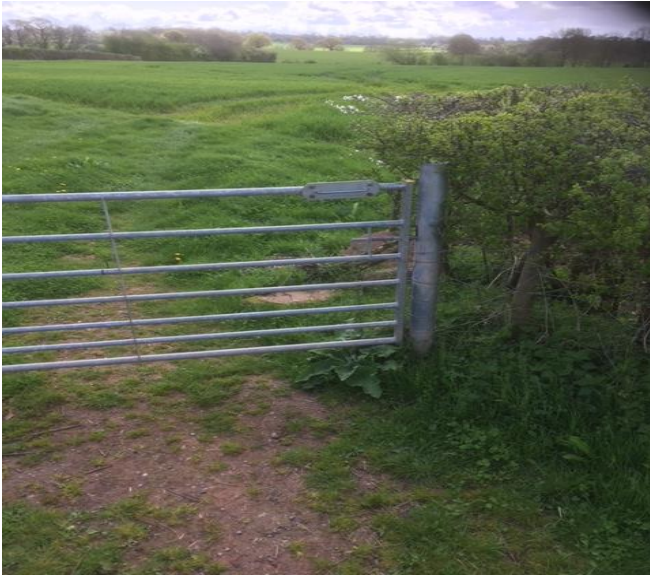
Photo 21. HU 4.2 (2018)

Route then crosses directly through a field regularly filled with cattle (and occasionally a bull) then through another gate HU 4.2 (Photo 21). The horse-friendly long handle was removed a number of years ago making it now necessary to dismount to open – not great if the bull is in the vicinity. **No Change since 2018.**

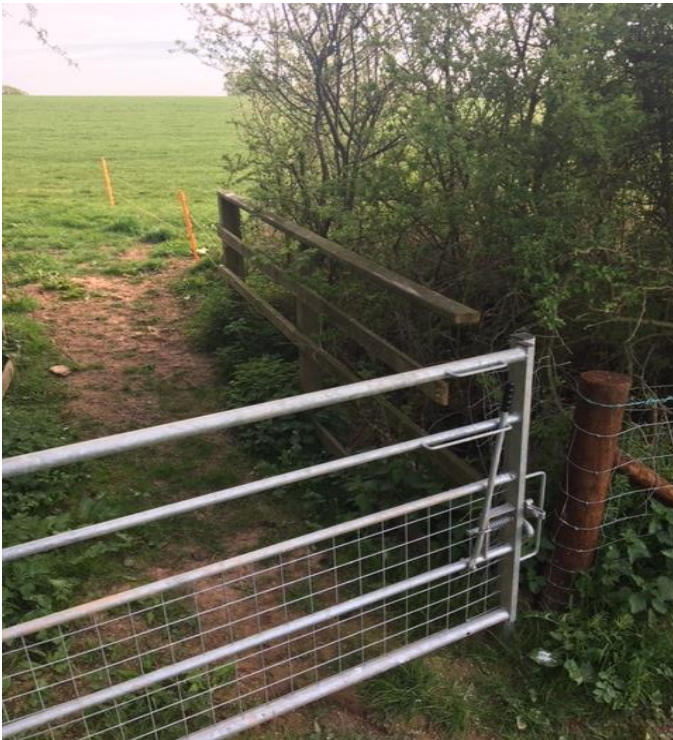
Photo 22. HU 4.3 (2020)

Route then runs into a further field that leads down to gate HU 4.3 over a narrow bridge (Photo 22). This gate was replaced in 2019, can be opened from the mounted position, although the spring has been set too tight and the gate can close quickly into the rider passing through.

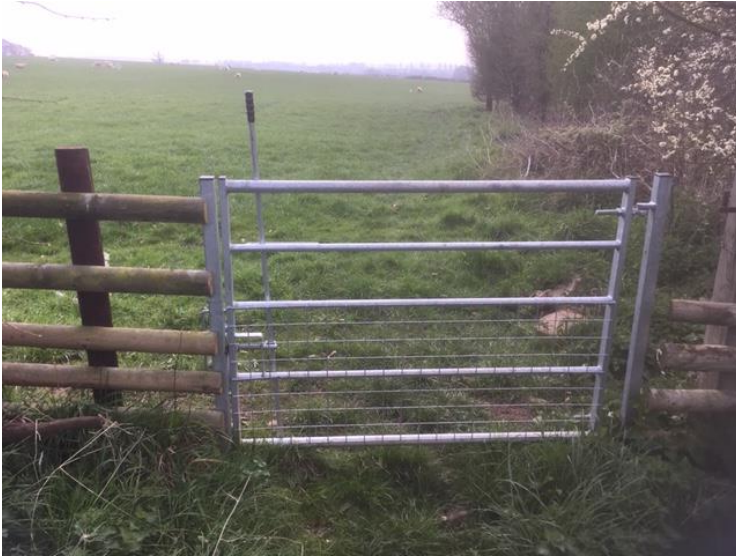
Photo 23. HU 4.4 (2019)

Route then heads towards Buckland where a new gate HU 4.4 (Photo 23) was installed in 2018. This is the perfect gate for a Bridleway: it can be opened easily from the mounted position with one hand and has been properly fitted so that it swings back gently to close once the rider passes through. In a perfect world all gates would be like this one. **No Change since 2018.**

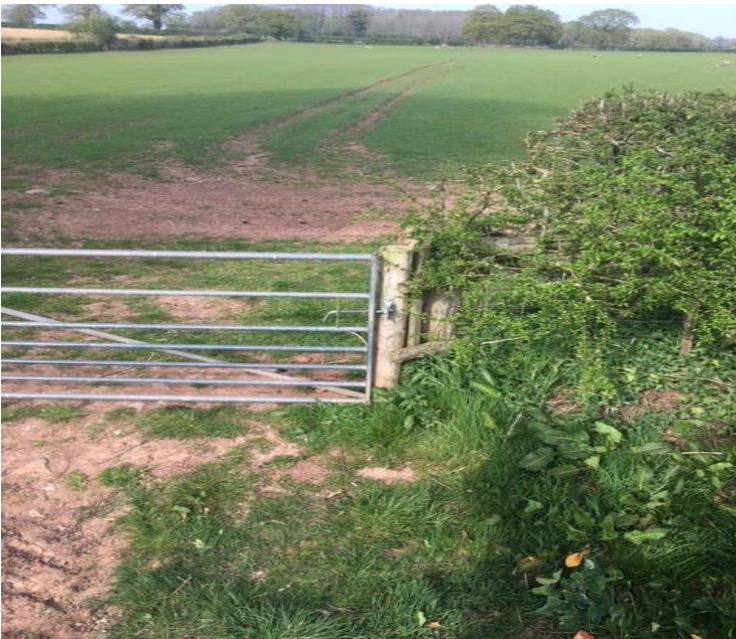
Photo 24. HU 4.5 (2020)

Gate HU 4.5 requires two hands to open from the dismounted position and is difficult to close as it has dropped slightly (Photo 24). **No Change since 2017.**

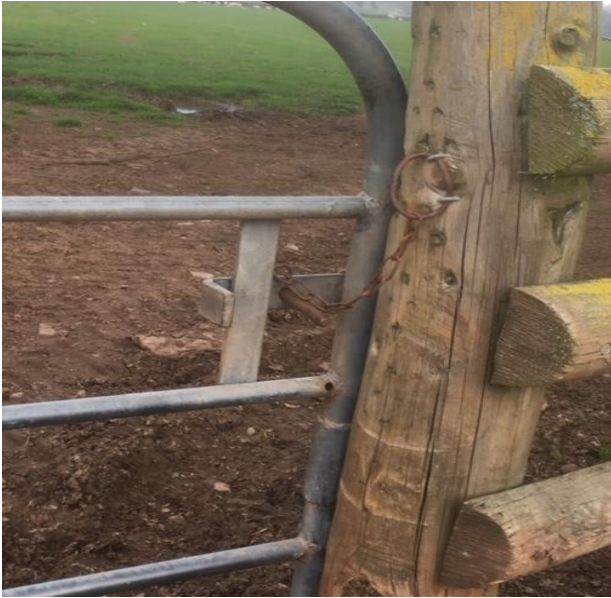
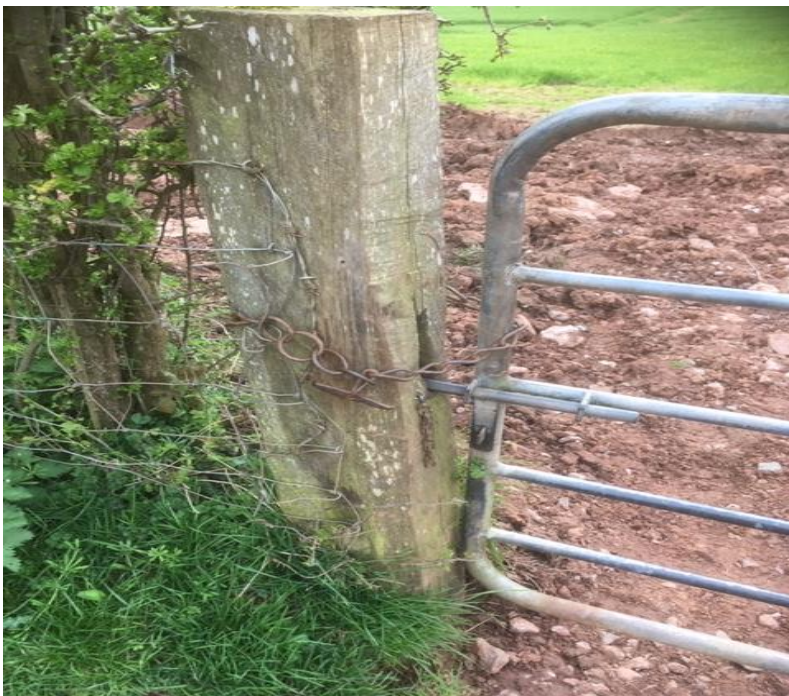
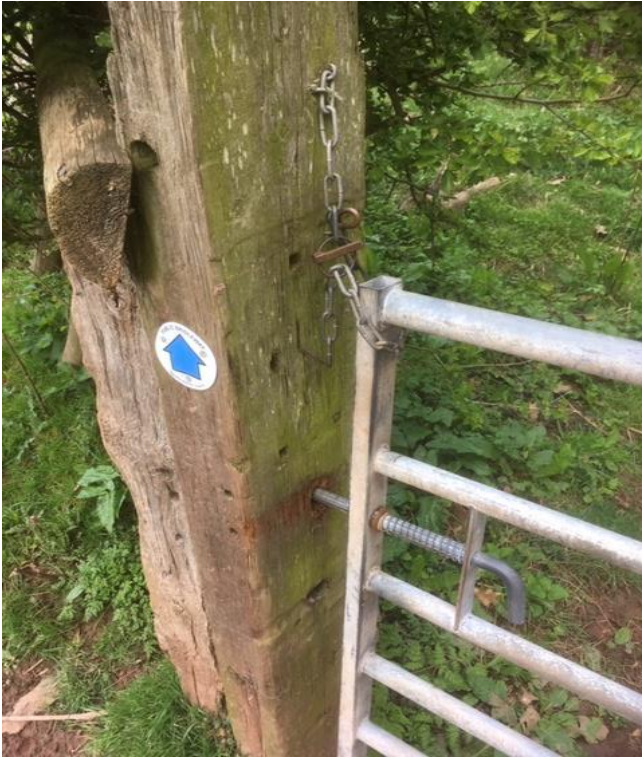
All further gates HU 4.6, HU 4.7, HU 4.8 (Photos 24,25 and 26) to Buckland are chained and difficult to open and require riders to dismount multiple times and open with two hands. Because of this, riders are discouraged from using this route and it now sees little traffic. **No Change since 2017.**

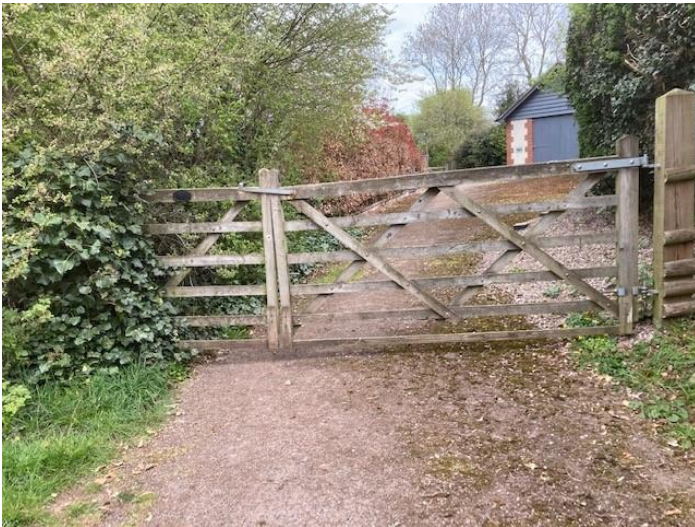
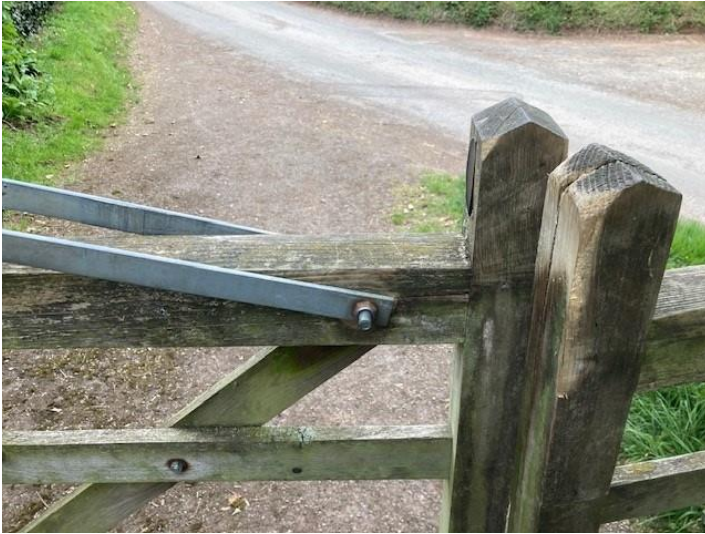
The route starts through a double gate HU 10.1 (Photo 28) that can be difficult for riders. The two gates do not close easily (Photo 29) and need to be lifted with two hands to close.

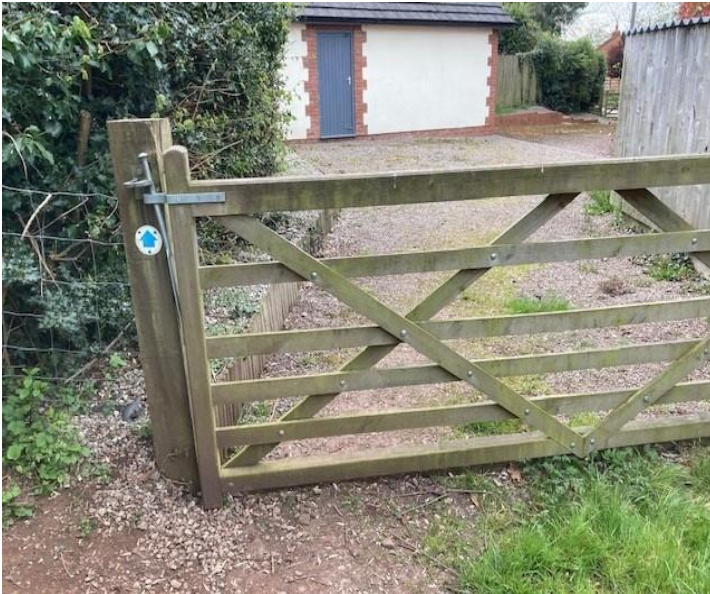
Photo 30. HU 10.2 (April 2021)

Gate HU 10.2 (Photo 30) can be opened from the mounted position.

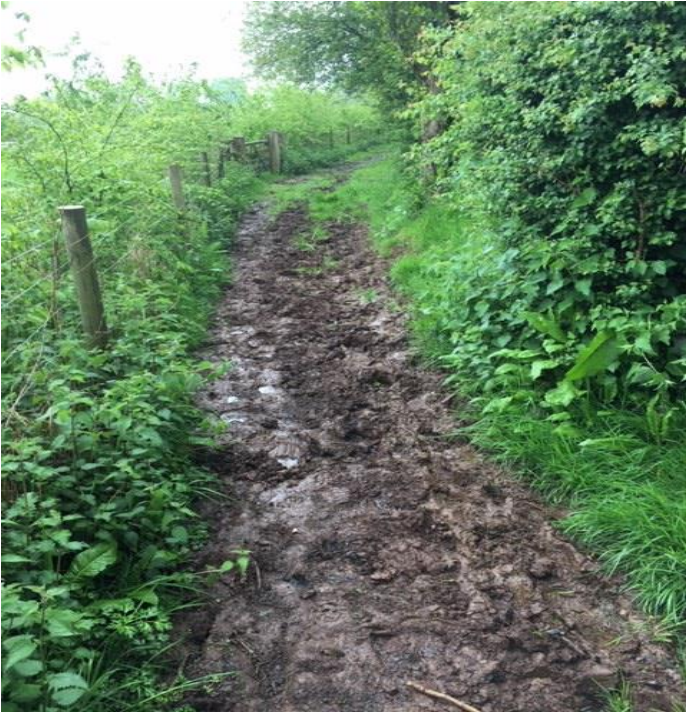
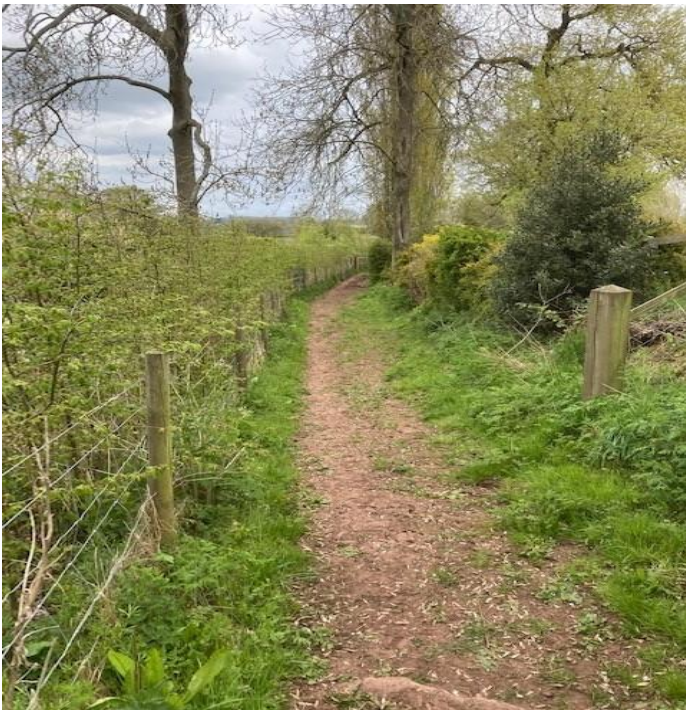
Beyond HU 10.2, the drainage has improved somewhat over the last year (compare April 2020 with April 2021 - Photos 31 and 32). The new owners have fenced off the PROW to the correct width and access is better than previously.

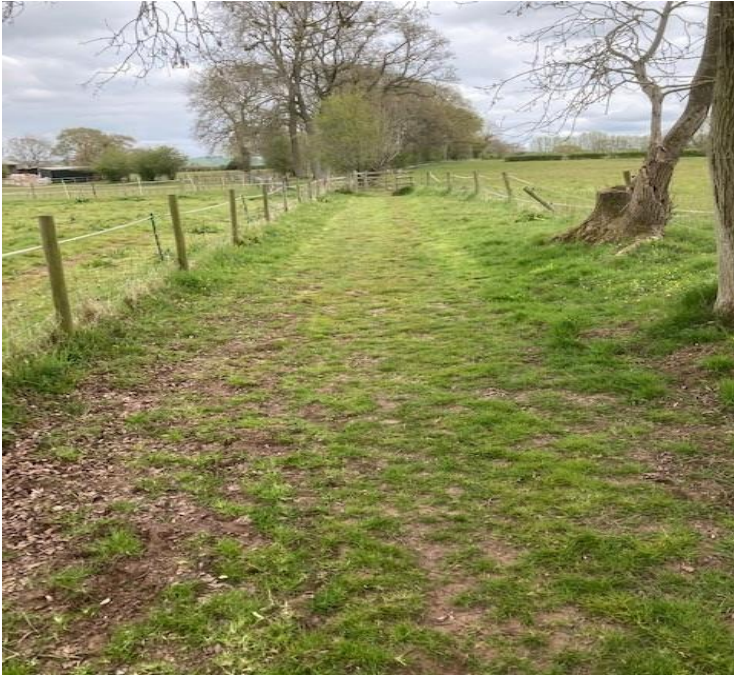
Photo 33. HU 10 2-3 (April 2021)

Someone is maintaining the route (HU 10 2-3) as the grass has recently been cut (Photo 33).

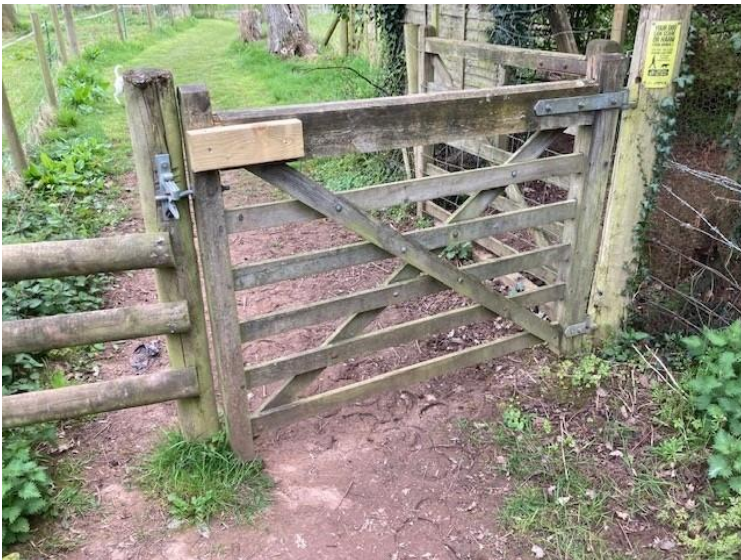
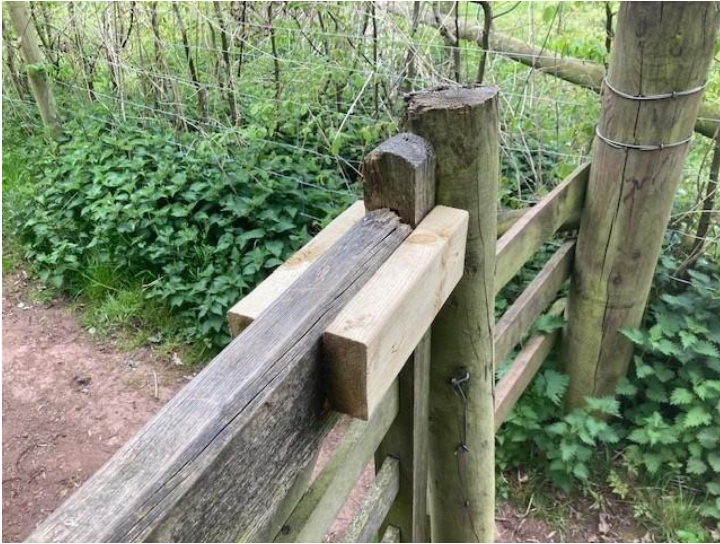
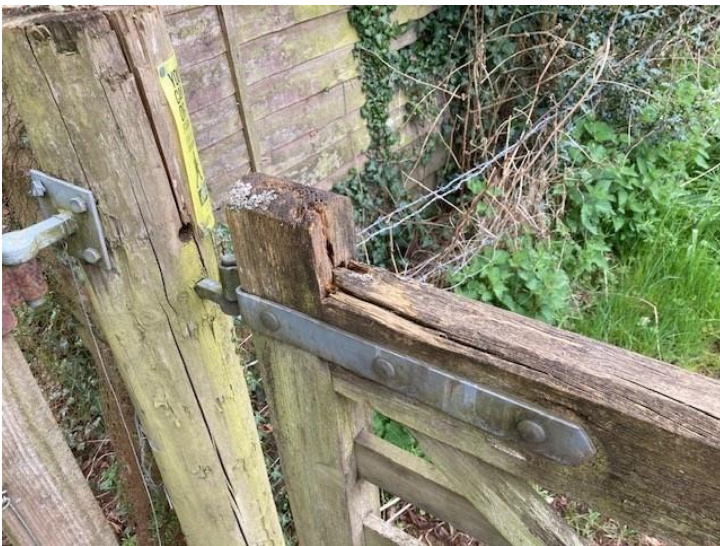
Gate HU 10.3 (Photo 34) has had some DIY repairs (Photo 35) but is in need of replacement as it is rotten in parts (Photo 36).

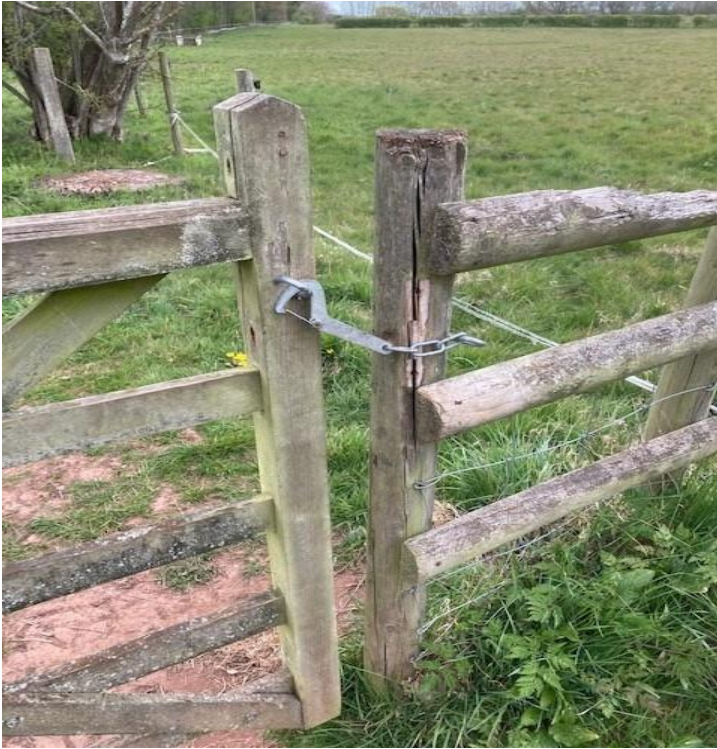
Photo 36. HU 10.4 (April 2021)

The catch on Gate HU 10.4 (Photo 36) is not the standard for a PROW but can be operated from the mounted position with care.

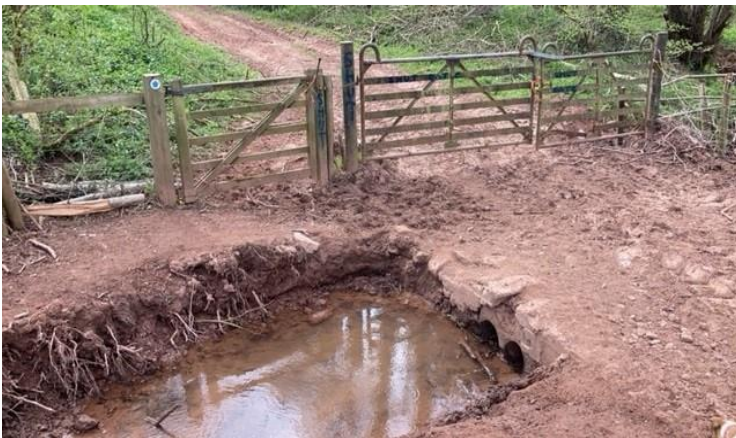
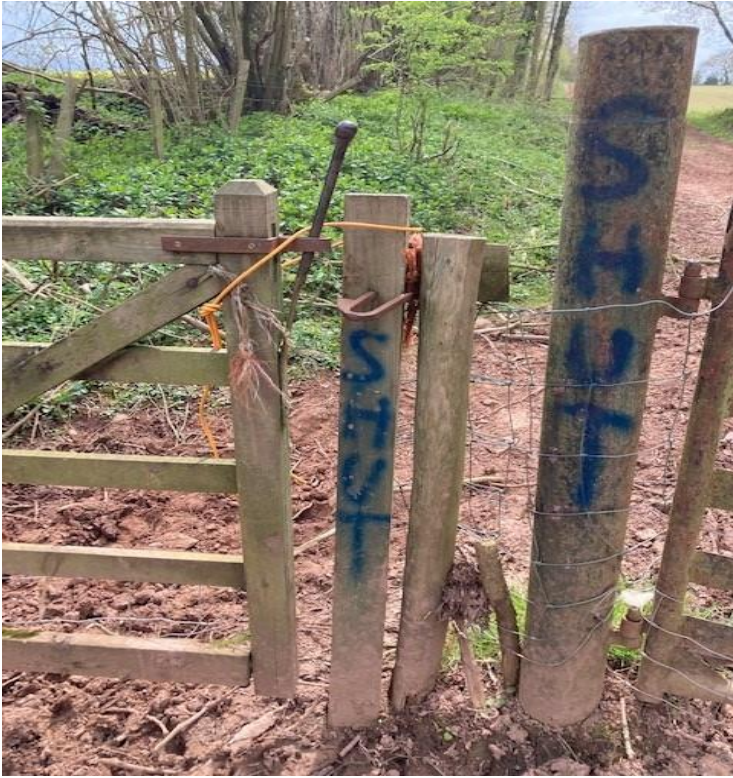
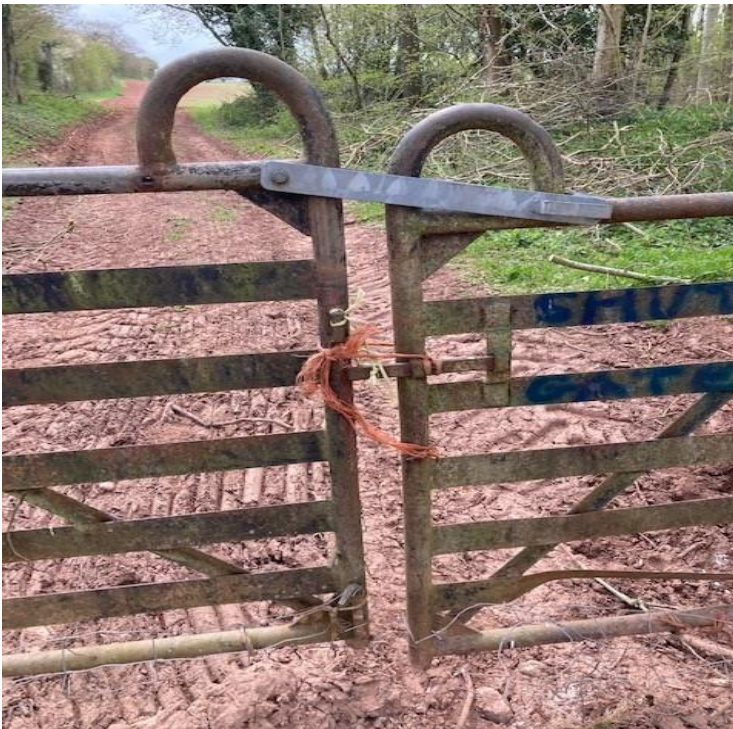
Gate PG 11.1 has been removed and is now just a gap in the hedge. Gate PG 11.2 is difficult to navigate due to the close proximity of the recently dug drainage trench (Photo 37) and the gate latch of the single gate (single (Photo 38) and double (Photo 39)) needs replacing.

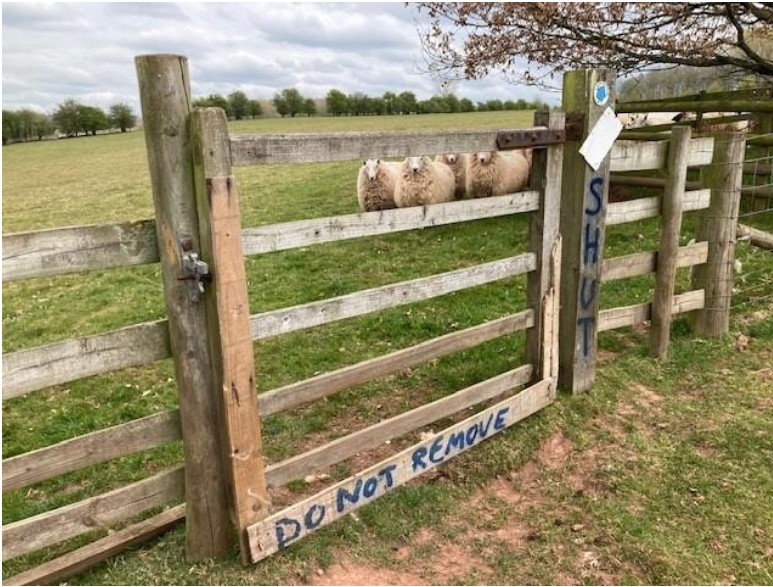
Photo 40. PG 11.3 (April 2021)

From the dingle, the route rises towards gate PG 11.3 (Photo 40) just below Sheepcote. The gate can with some dexterity be operated from the mounted position.

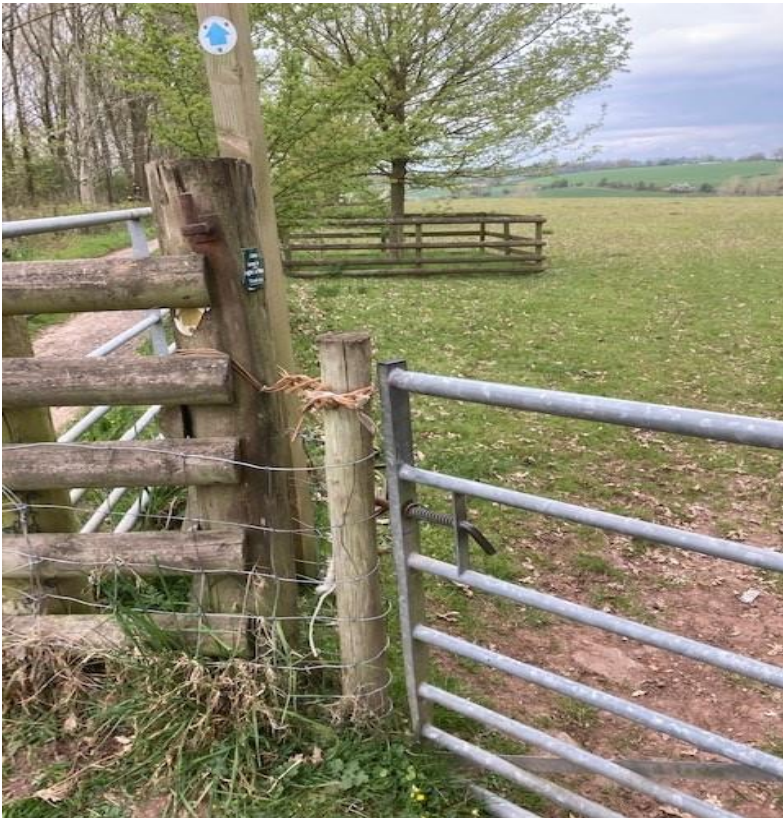
Photo 41. PG 11.4 (April 2021)

Gate PG 11.4 (Photo 41) can be opened from the mounted position.

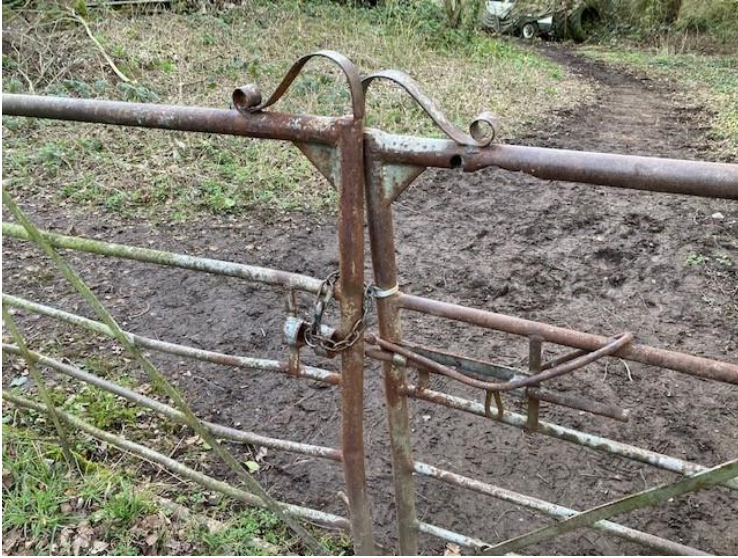
Photo 42 PG 11.6 (March 2021)

The gate at PG 11.6 (Photo 42) is chained and requires a dismount and two hands to open and close. **No Change since 2017.**

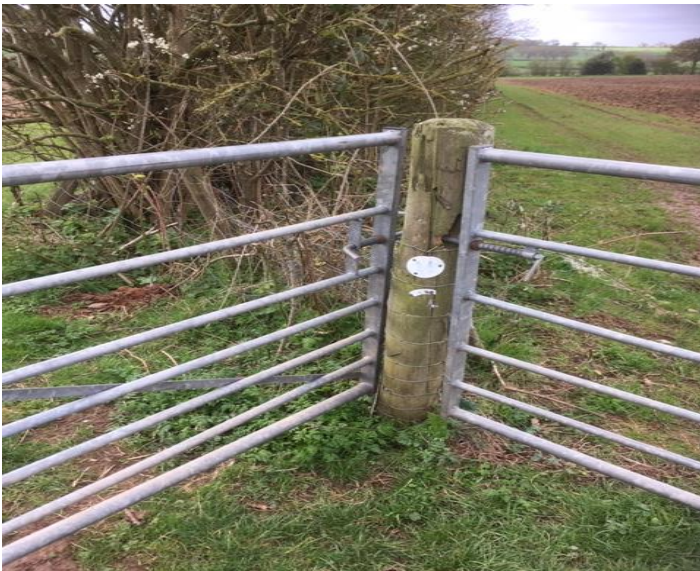
Photo 43. PG 11.9 (April 2019)

From Marston Cottages the route enters the field through PG 11.9 (Photo 43) and runs directly across to Marston Firs. In previous years riders were content to skirt around the field as the landowner had left an excellent headland. This year the route is cropped over and there is no headland, so riders will need to find their own route through the crop (Photo 44).

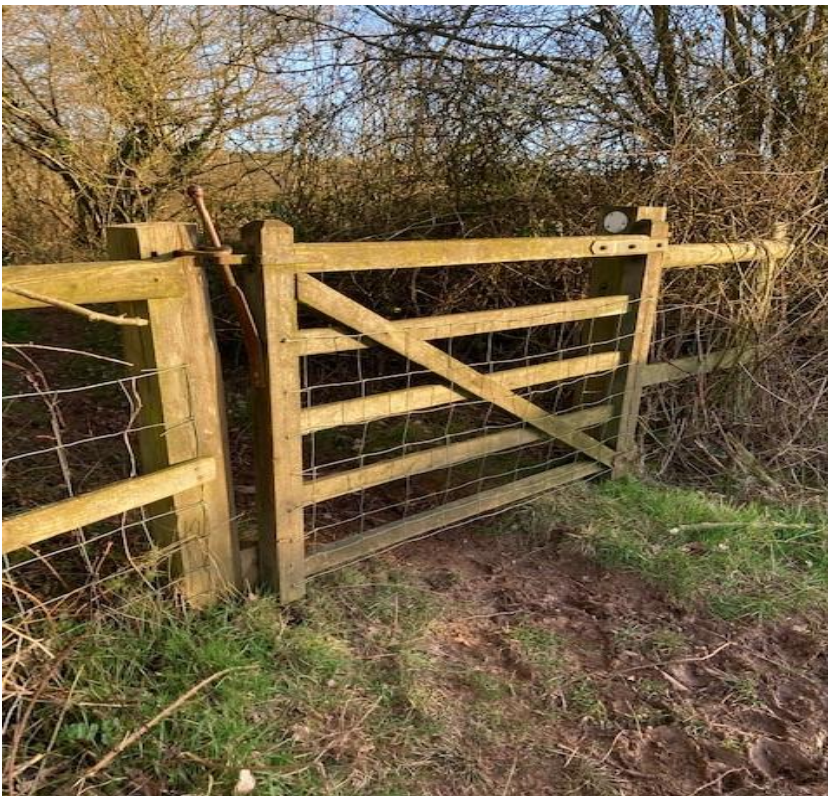
Photo 45. PG 11.10 (March 2021)

The route enters Marston Firs through gate PG 11.10 (Photo 45) which has been improved since my previous reports and can now be opened when mounted.
