# Humber, Ford and Stoke Prior Bridleways

Annual Report - 2021

Iain Cholerton  
1<sup>st</sup> May 2021

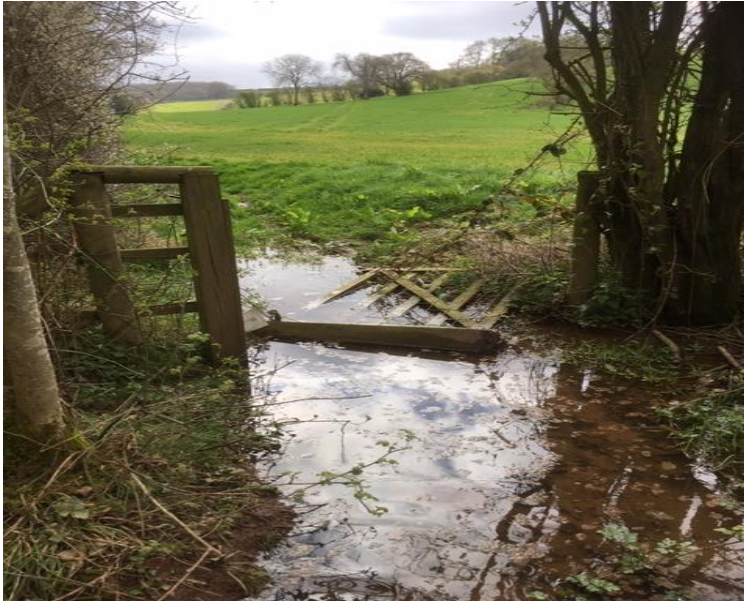
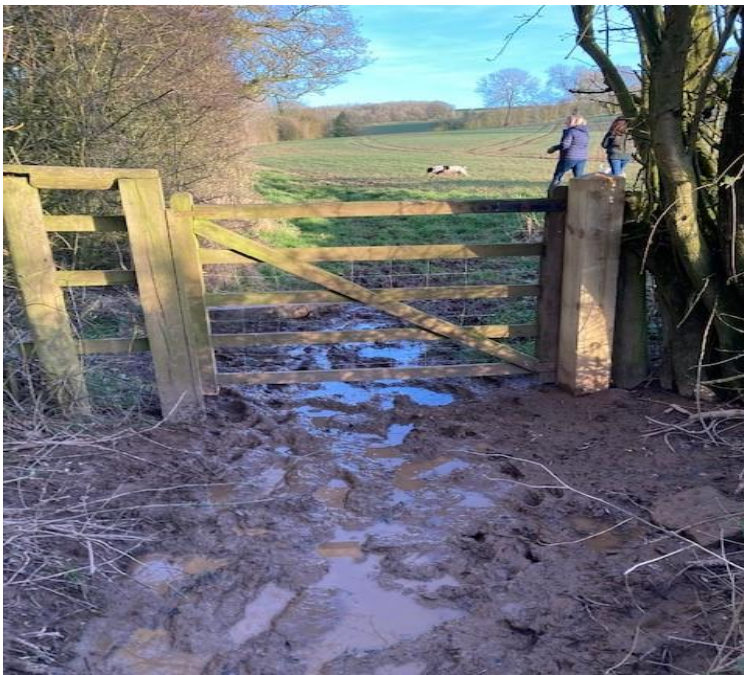
The route exits the wood through PG 11.11 and continues to Hegdon Hill outside the Parish Boundary. Since 2019 (Photo 46) the gate has been replaced. Although not as wet as previously, at certain times of the year it remains difficult for horses to use this gate due to the boggy ground (Photo 47).

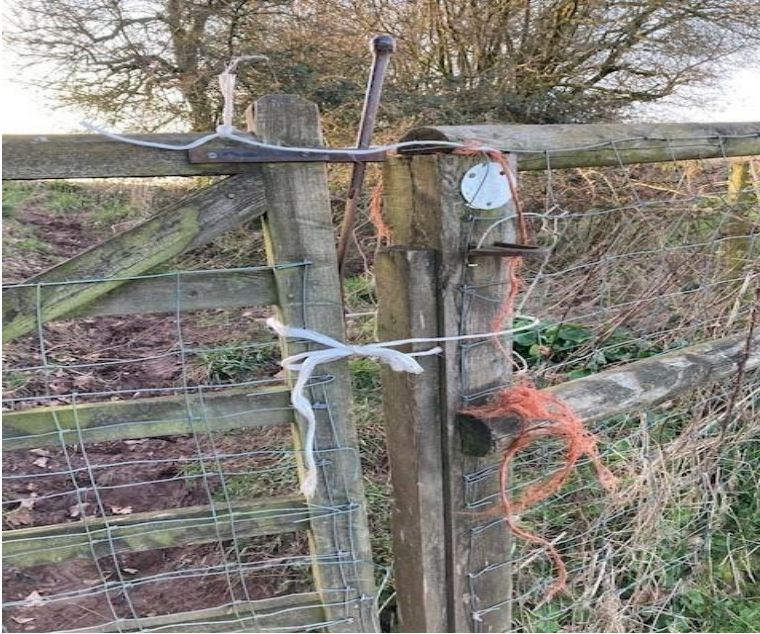
Photo 48. PG 11.12 (March 2021)

Beyond gate PG 11.11 is outside the Parish boundary – into Pencombe PC – so for information only. The gate PG 11.12 is tied up with binder twine, the latch does not fit into the catch and it is a dismount and two-handed job to open.

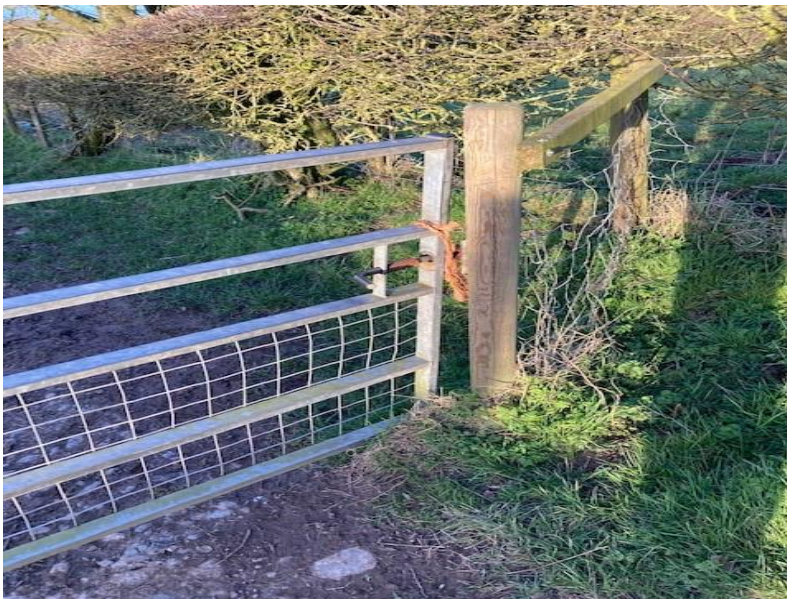
Photo 49. PG 11.13 (March 2021)

Also, at the top of the hill at PG 11.13 the gate is tied with binder twine and needs a dismount and two hands to open.
